DNA 4765F

PRELIMINARY ASSESSMENT OF **VULNERABILITY OF TACTICAL MISSILE** MATERIALS IN NUCLEAR DUST ENVIRONMENTS

Prototype Development Associates, Inc.

31 October 1978

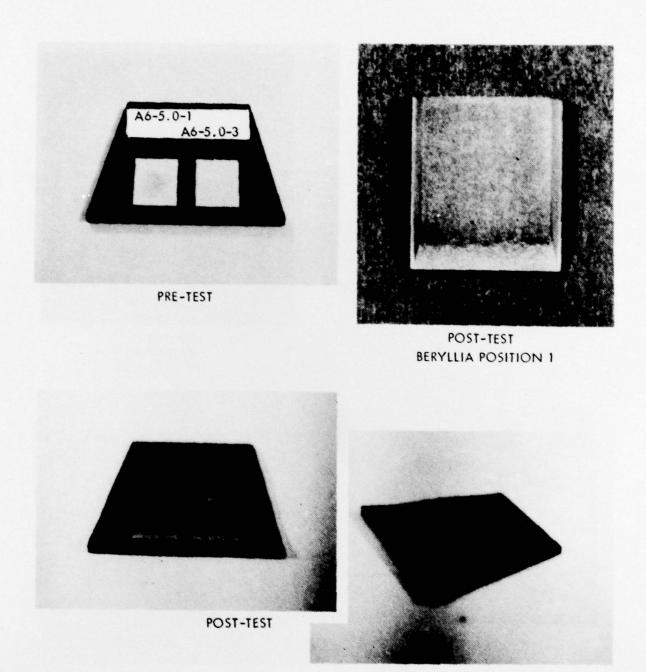
Figure A2. Pre- and post-test photographs of Beryllia (Strut 2, Positions 1 and 2).

The results in Tables 5 and 6 indicate that, for the present test conditions, alumina and beryllia are the most erosion-resistant materials tested. The performances of Pyroceram and Rayceram Cordierite also were very good. These four materials were substantially better than the other three candidate radome materials (the measured recession rate of the next best radome material was a factor of nearly 25 greater than the recession rate of Rayceram Cordierite) and should be included in any future evaluation and/or characterization programs.

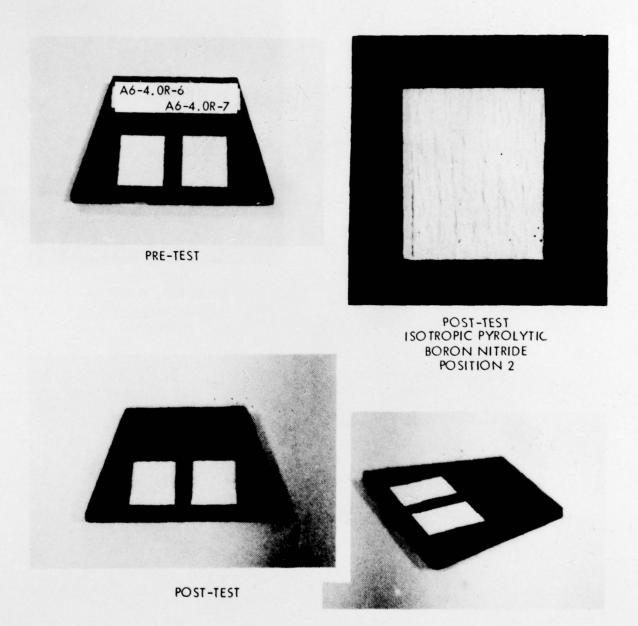
Figure A7. Pre- and post-test photographs of Isotropic Pyrolytic Boron Nitride (Strut 6B, Positions 1 and 2).

Of the candidate antenna window materials, 1D Celcon/quartz clearly was the most erosion-resistant in the conditions tested (a factor of almost 25 lower recession rate than the next best material). Future evaluations of this material also should consider the compatibility of ablation performance and erosion resistance with representative heatshield materials in order to prevent the development of surface protuberances during flight.
